CALIFORNIA DEPARTMENT OF CONSERVATION
DIVISION OF MINES AND GEOLOGY

**FAULT EVALUATION REPORT FER-234
SURFACE FAULT RUPTURE ALONG THE JOHNSON VALLEY,
HOMESTEAD VALLEY, AND RELATED FAULTS
ASSOCIATED WITH THE
M_s 7.5 28 JUNE 1992 LANDERS EARTHQUAKE**

by
William A. Bryant
Associate Geologist
November 17, 1992

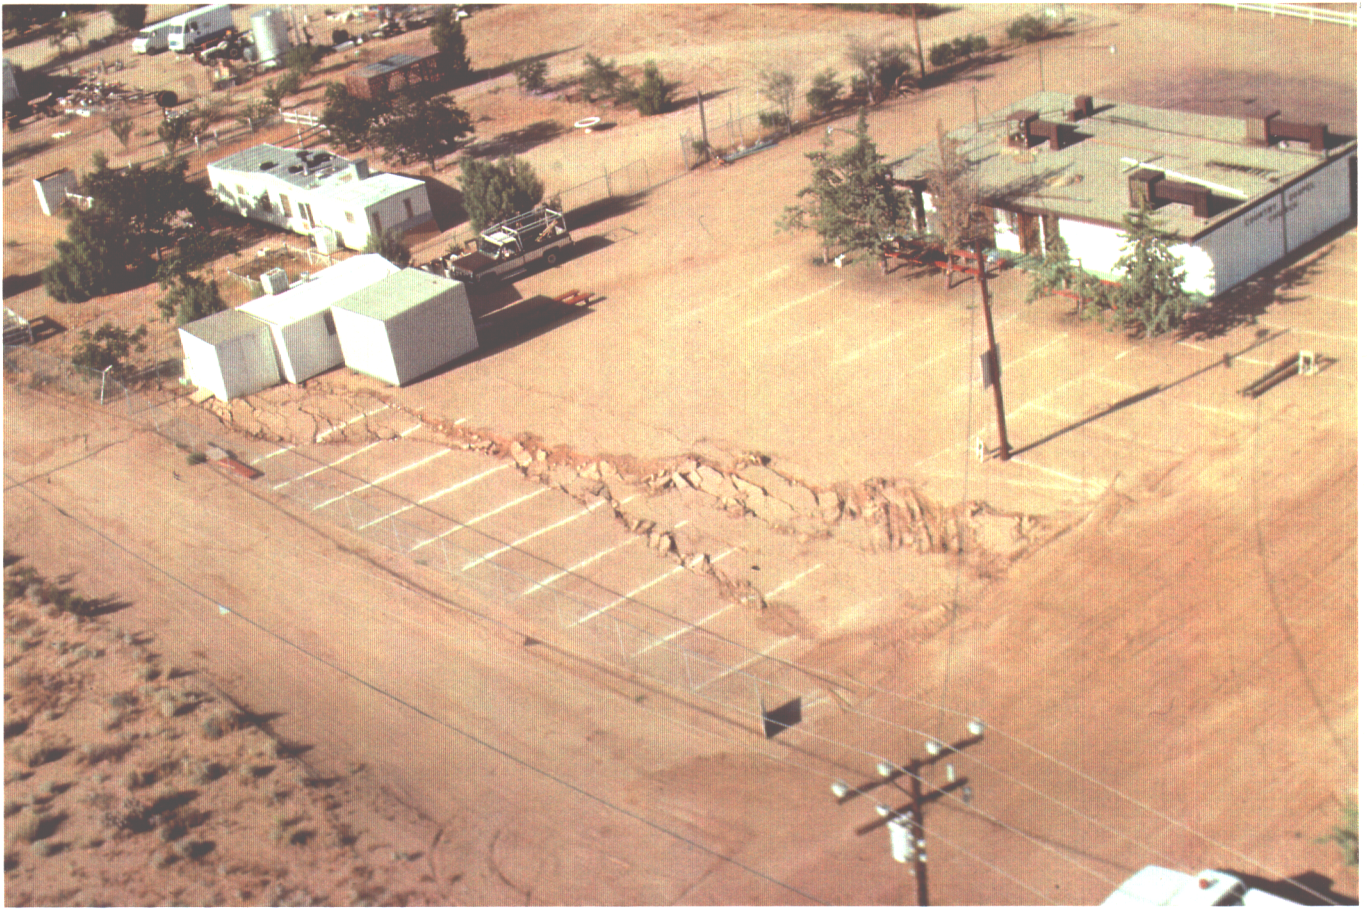
displacement was generally down to the west and reached a maximum of 40 cm at locality 4 (Figure 3a) and locality 5 (Figure 3b).

Photo 1 (to FER-234). Aerial view of the Johnson Valley fault at locality 5 (Figure 3b). Fault has offset the chalk parking stripes 230 ± 10 cm right-laterally across a zone about 10 meters wide. A down-to-the-west vertical component of 40 cm was measured.

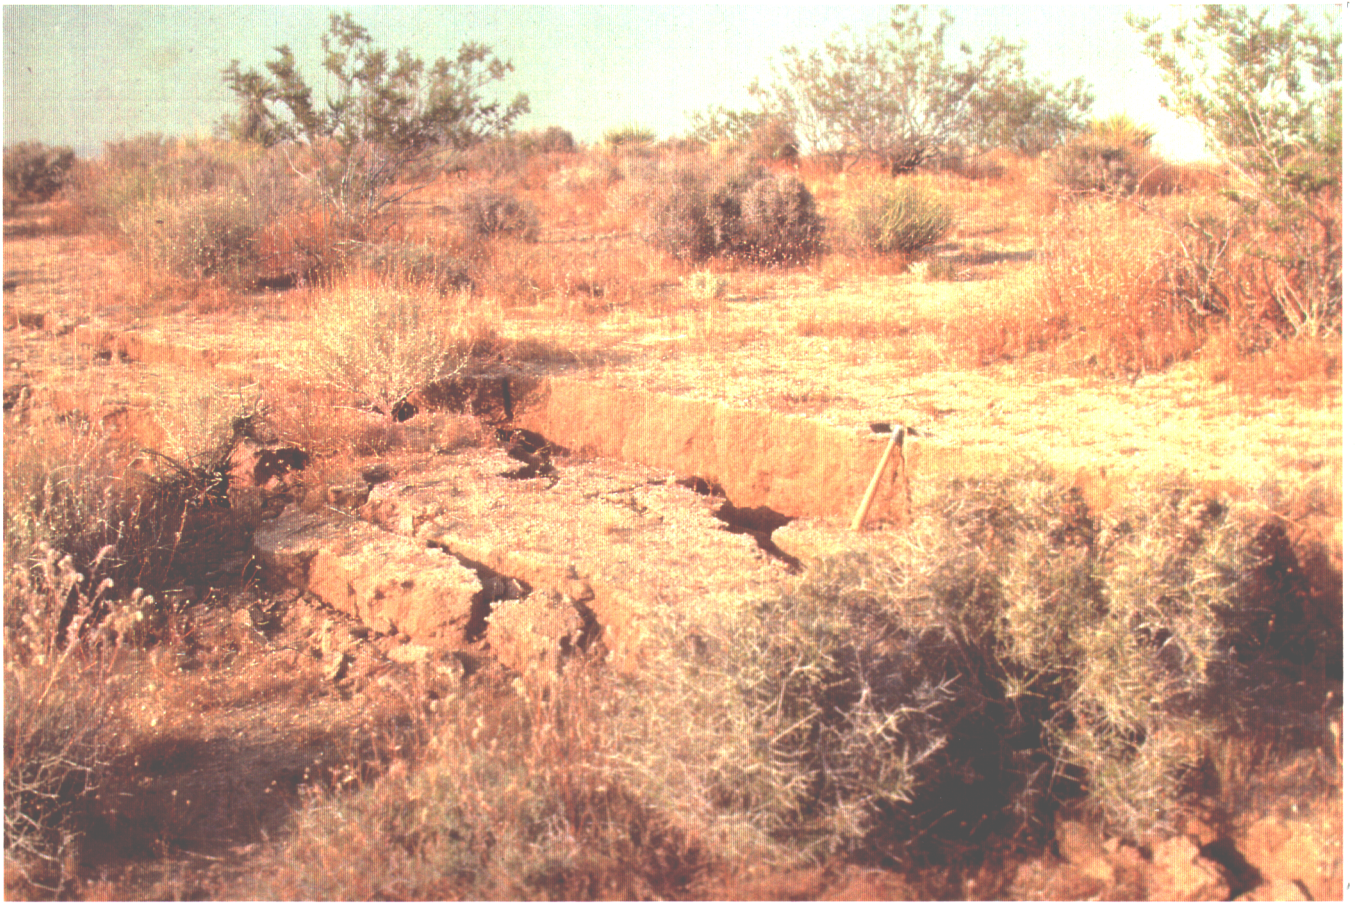
Photo 2 (to FER-234). A well-defined west-facing scarp in late Pleistocene alluvium delineates surface fault rupture along the Johnson Valley fault in the Flamingo Heights area (locality 18, Figure 3a).

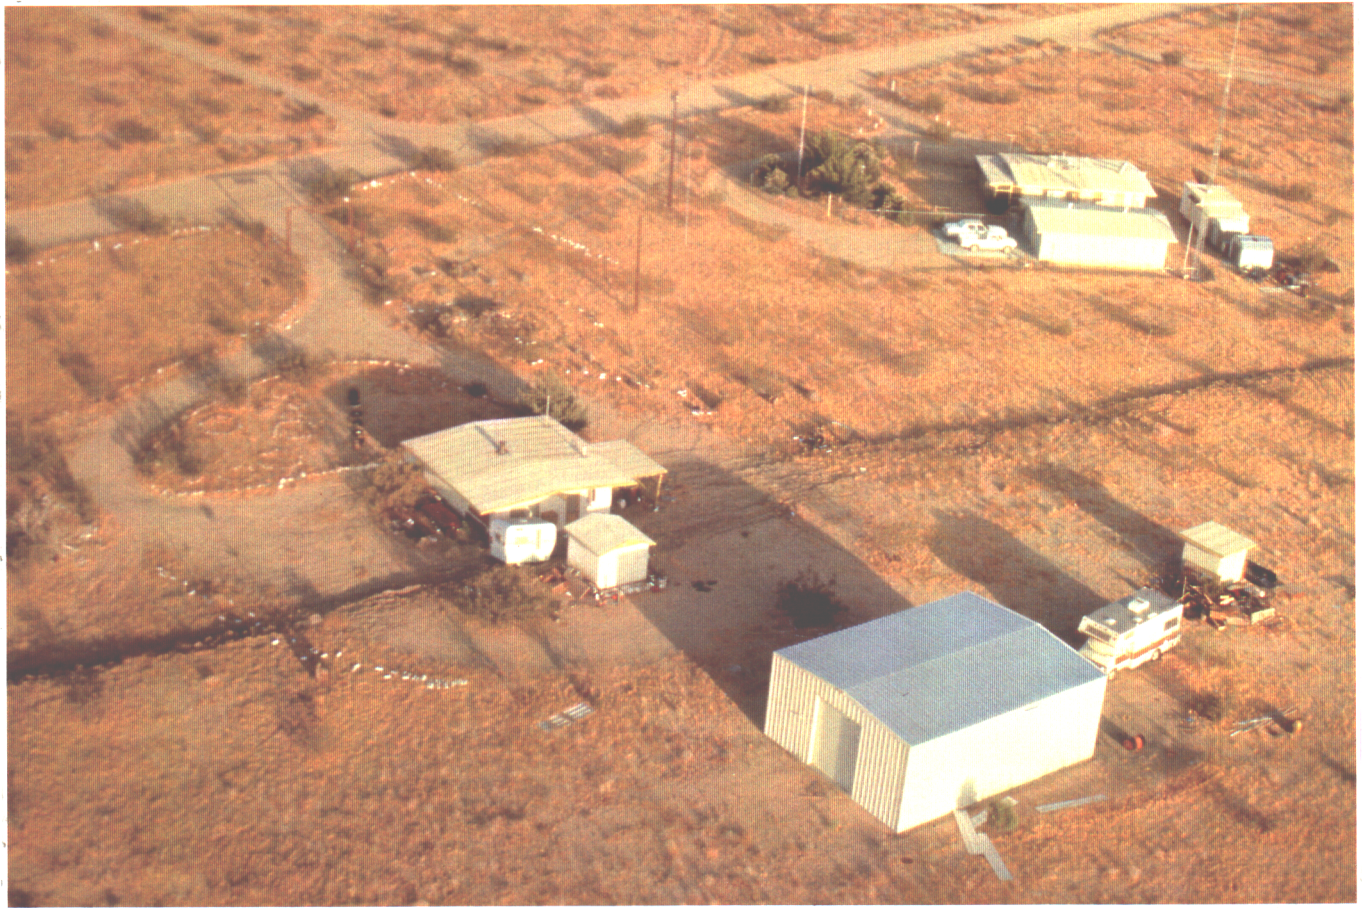
Photo 3 (to FER-234). The previously unmapped "Kickapoo" fault was characterized by approximately 70 cm right-lateral and up to 106 cm of vertical (down to the east) displacement at this location (just north of locality 8, Figure 3b). A left-step in the fault rupture spared the house from further damage.

Zone for special studies traces of the Kickapoo fault that ruptured in the 1992 Landers earthquake as indicated in Figure 2b. Because the Kickapoo fault consists of a broad and complex zone of fault rupture, fault rupture recommended for zoning have the following two criteria: (1) displacement is greater than 1 cm, and (2) the ruptures must have continuity along a linear trend that indicates fault rupture rather than fracturing caused by shaking or lateral spreading. Principal reference cited should be Bryant, this report.

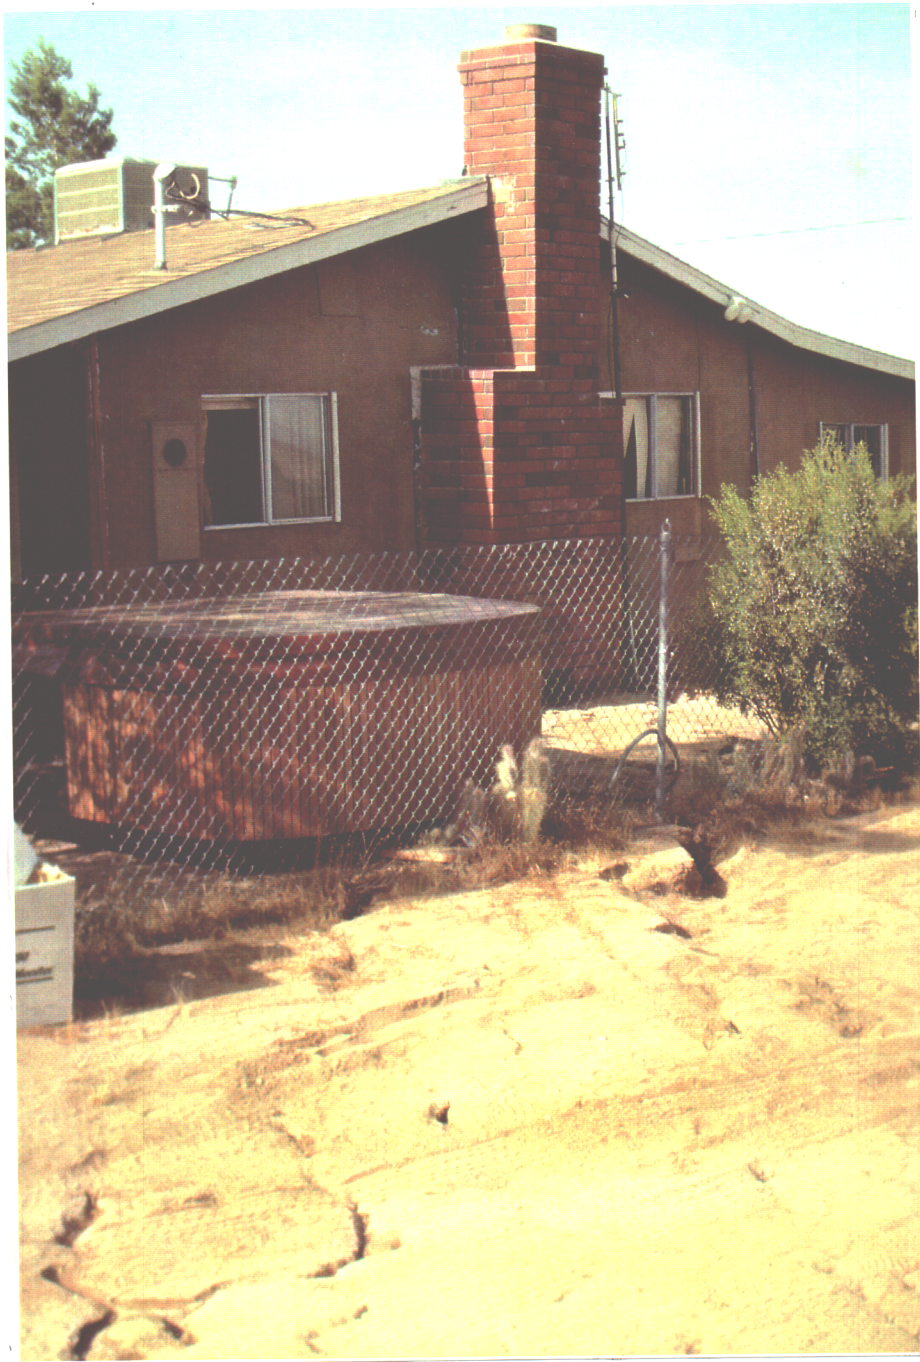
Fault rupture occurred west of the Johnson Valley fault in the Flamingo Heights area along several northeast trending faults (Figures 3a,3b; Photos 4 and 5). This complex zone of generally right-lateral strike-slip faults was not previously recognized. Magnitude of offset reached a maximum right-lateral displacement of 60 cm with a vertical component of 20 cm (down-to-the east) (locality 15, Figure 3a). Several faults also displayed left-lateral strike-slip displacement up to about 5 cm. Many ruptures were characterized primarily by extension and vertical displacement.

Photo 4 (to FER-234). Several previously unmapped northeast-trending faults (Fault Zone A) occurred west of the Johnson Valley fault in the Flamingo Heights area. The house at locality 19 (Figure 3a) was damaged by a fault that had 10 cm of right-lateral and 10 cm of southeast side down vertical displacement.

Zone for special studies traces of Fault Zone A that ruptured in the 1992 Landers earthquake as indicated in Figures 2a and 2b. Because Fault Zone A consists of a broad and complex zone of fault rupture, fault rupture recommended for zoning have the following two criteria: (1) displacement is greater than 1 cm, and (2) the ruptures must have continuity along a linear trend that indicates fault rupture rather than fracturing caused by shaking or lateral spreading. Principal reference cited should be Bryant, this report.

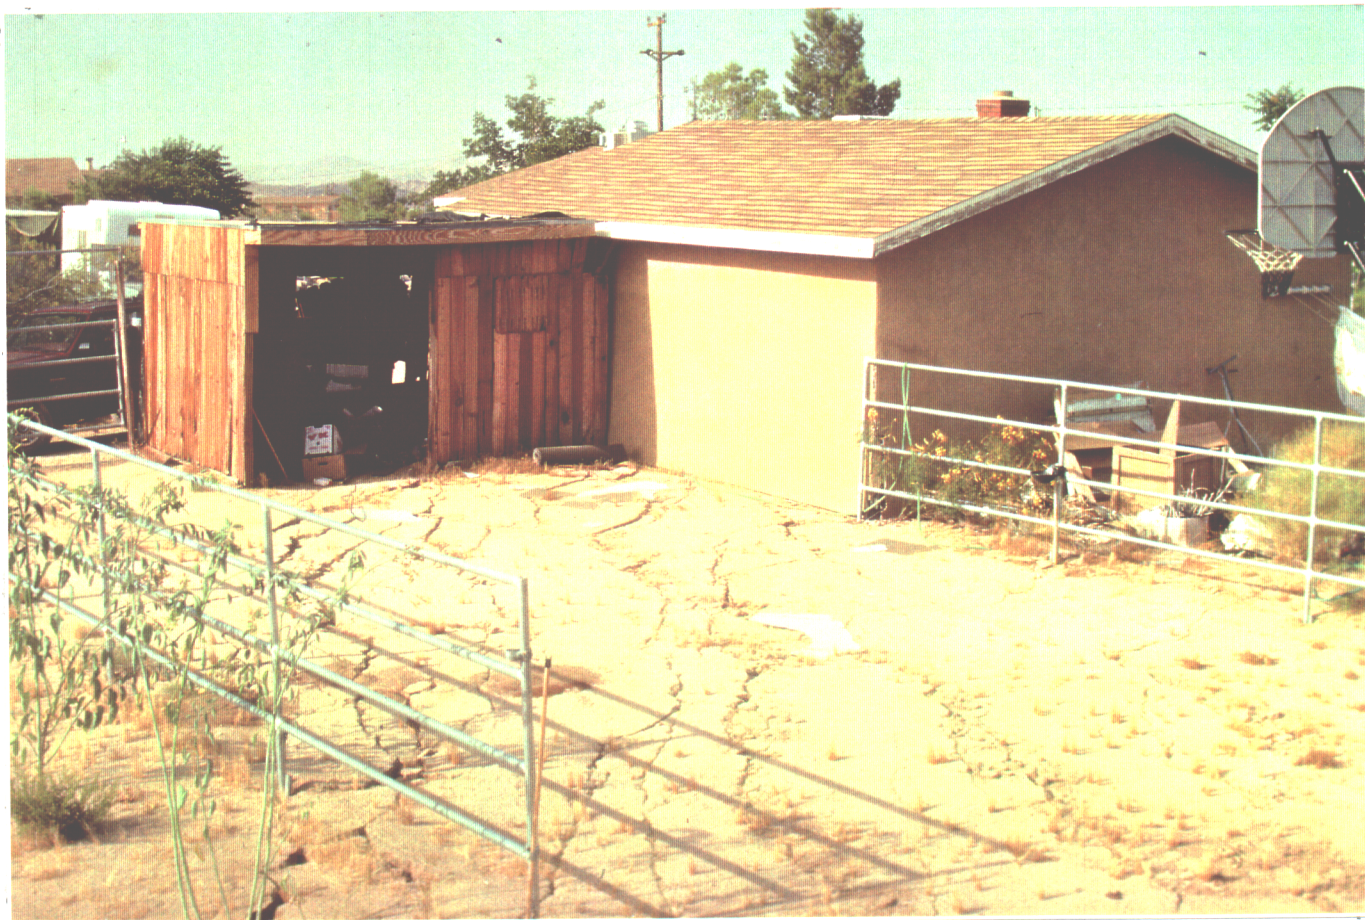
Photo 5 (to FER-234). The ruptures at locality 19 (Figure 3a; Photo 4) are characterized by a complex pattern of extensional and right-oblique slip offset. View is to the northeast of a garage damaged by surface fault rupture.
